Maintenance Rating Program

Triangle Expressway

2014 Fourth Quarter and Annual Report

NCTA Triangle Expressway Roadway and Facility Maintenance Performance Rating Program

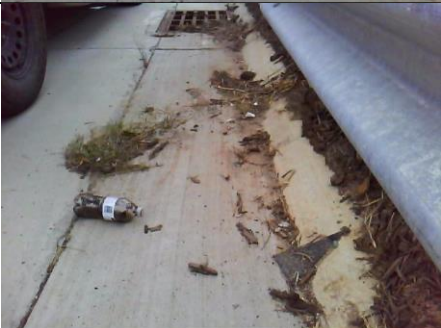
A10, A11
2	Concrete	CG_173	Material Accumulation

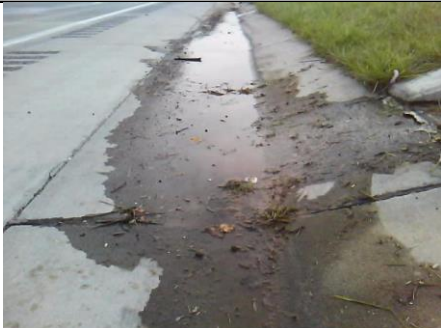
#	Material Type	Object ID	Failure Type	Photo	GIS Reference Page
4	Valley	CG_251	Material Accumulation

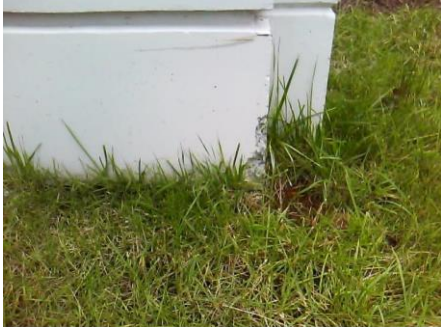
#	Material Type	Object ID	Failure Type	Photo	GIS Reference Page
1	Gantry Support	DS_222	Spalling

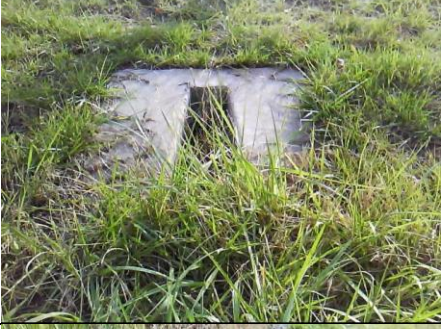
A52
2	Shoulder Drain	MDP_13	Obstruction

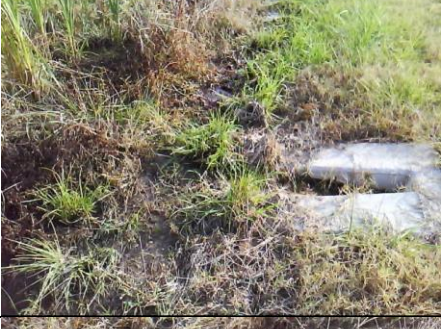
A13
3	Shoulder Drain	MDP_30	Obstruction

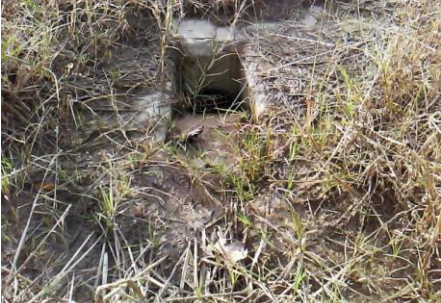
A16
4	Shoulder Drain	MDP_38	Obstruction

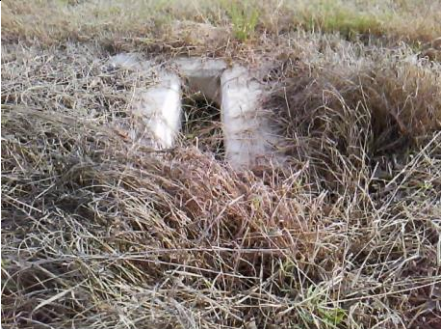
#	Material Type	Object ID	Failure Type	Photo	GIS Reference Page
5	Shoulder Drain	MDP_66	Obstruction

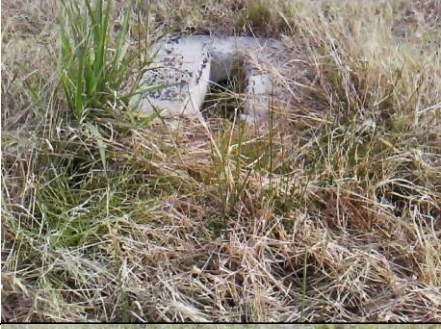
A22, A23
6	Shoulder Drain	MDP_68	Erosion

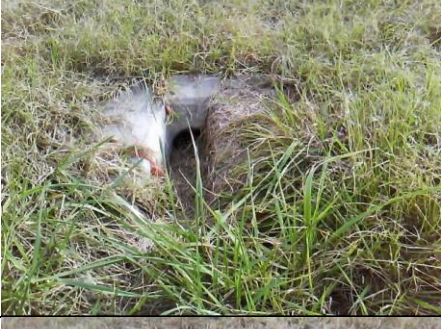
A23
7	Shoulder Drain	MDP_69	Obstruction

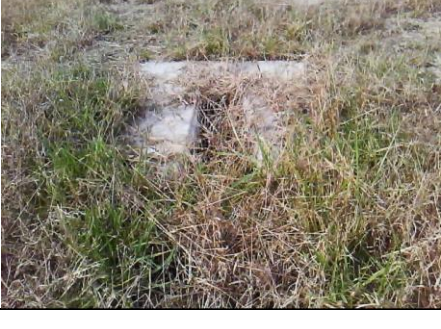
A24
8	Shoulder Drain	MDP_71	Obstruction

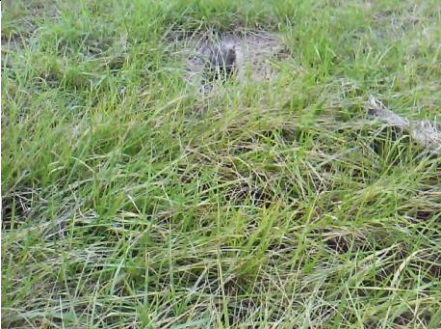
#	Material Type	Object ID	Failure Type	Photo	GIS Reference Page
9	Shoulder Drain	MDP_107	Erosion

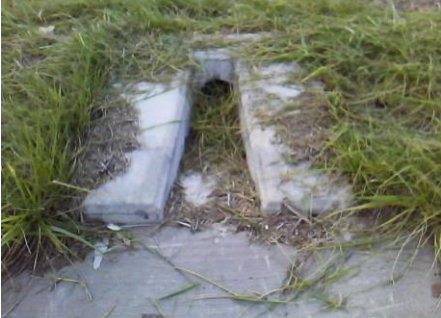
A32
10	Shoulder Drain	MDP_111	Obstruction

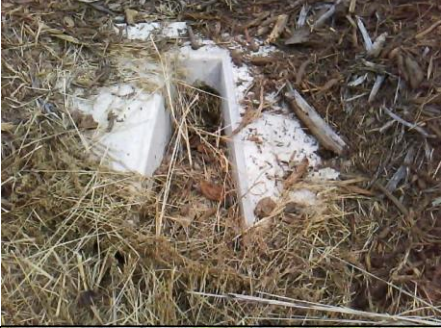
A32
11	Shoulder Drain	MDP_115	Obstruction

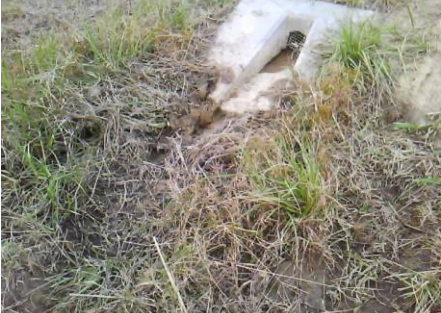
A32, A33
12	Shoulder Drain	MDP_120	Erosion

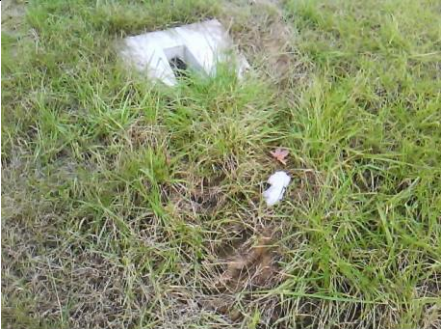
#	Material Type	Object ID	Failure Type	Photo	GIS Reference Page
13	Shoulder Drain	MDP_130	Erosion

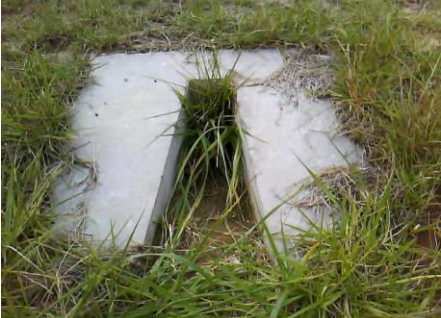
A36
14	Shoulder Drain	MDP_135	Obstruction

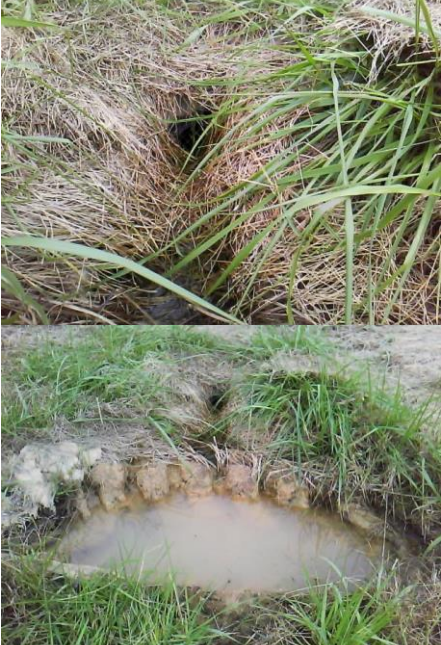
A37
15	Shoulder Drain	MDP_147	Obstruction

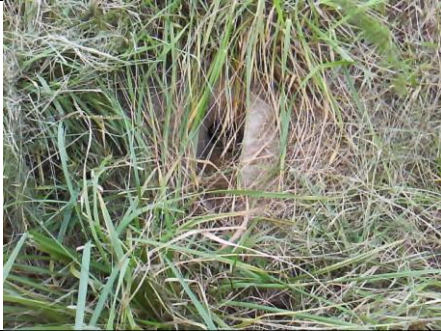
#	Material Type	Object ID	Failure Type	Photo	GIS Reference Page
16	Shoulder Drain	MDP_149	Erosion

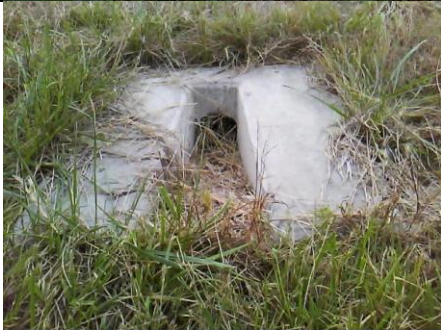
A39
17	Shoulder Drain	MDP_180	Obstruction

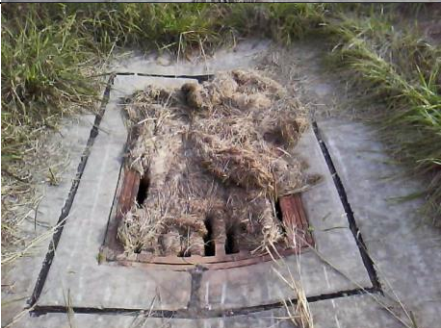
A52
2	Inlet	IN_275	Obstruction

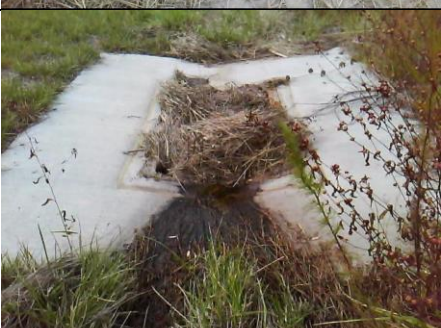
A8, A9
4	Inlet	IN_859	Obstruction

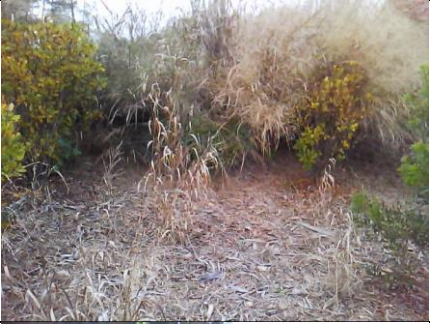
#	Material Type	Object ID	Failure Type	Photo	GIS Reference Page
1	Plant Bed	PB_53	Unhealthy

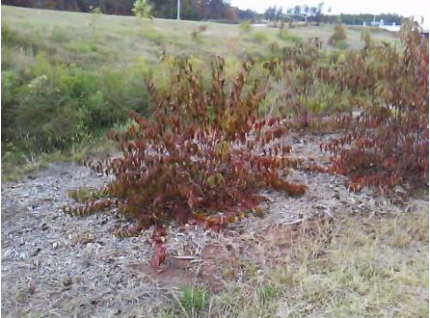
A54
2	Plant Bed	PB_71	Unhealthy

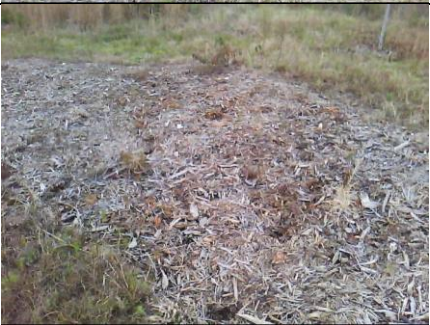
A53
3	Plant Bed	PB_80	Unhealthy

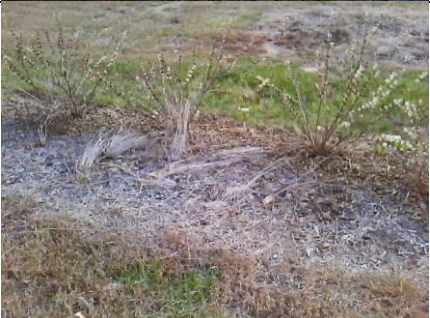
A55, A56
4	Plant Bed	PB_117	Unhealthy

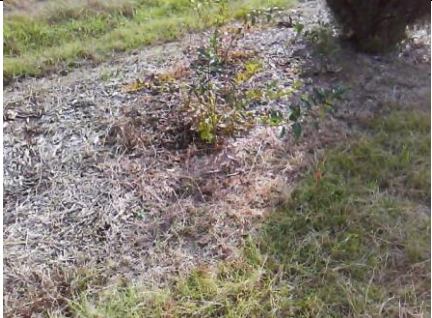
#	Material Type	Object ID	Failure Type	Photo	GIS Reference Page
5	Plant Bed	PB_167	Unhealthy

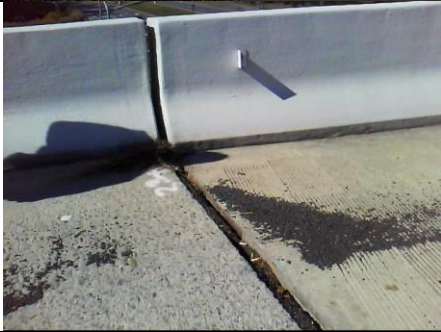
A20, A21
2	Asphalt	LS_281	Paved Shoulder Joint

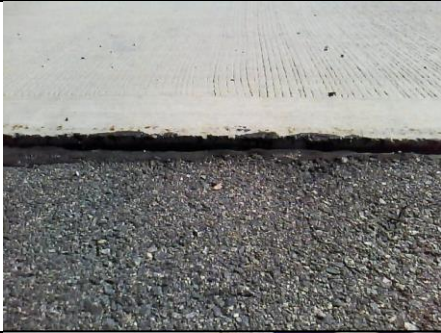
A54
3	Concrete	LS_325	Paved Shoulder Settlement

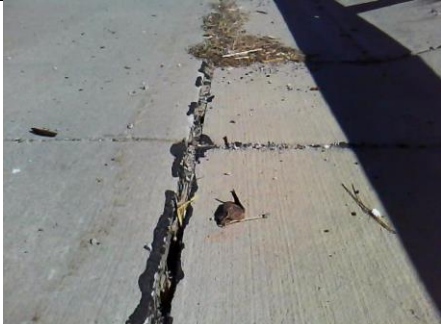
A6
4	Concrete	LS_340	Paved Shoulder Joint

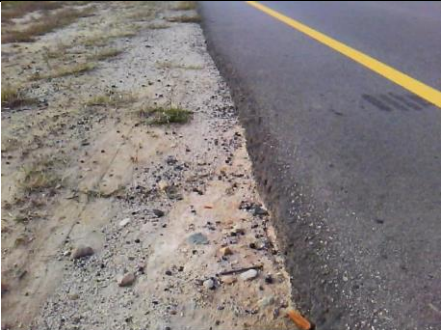
A56
2	Unpaved Shoulder	LS_542	Shoulder Dropoff

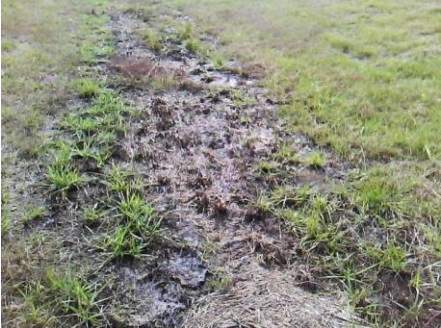
A47
2	Unpaved Lateral Ditch	LS_603	Erosion

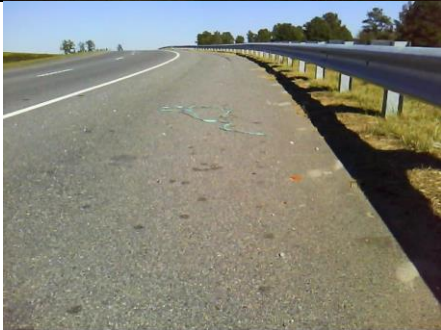
A17, A18
2	Asphalt	LS_302	Travelway Sweeping

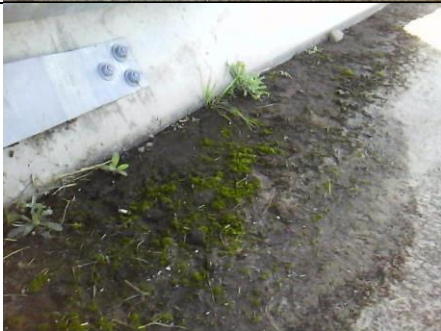
A2
3	Concrete	LS_325	Travelway Sweeping

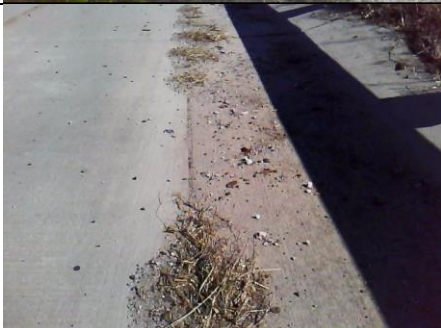
A6
4	Concrete	LS_340	Travelway Sweeping

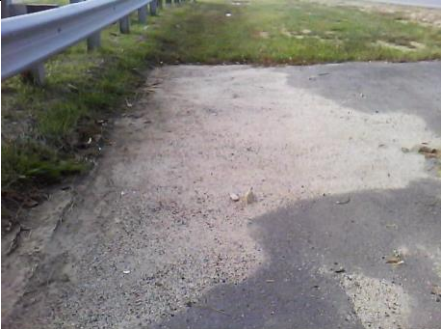
#	Material Type	Object ID	Failure Type	Photo	GIS Reference Page
5	Asphalt	LS_542	Travelway Sweeping

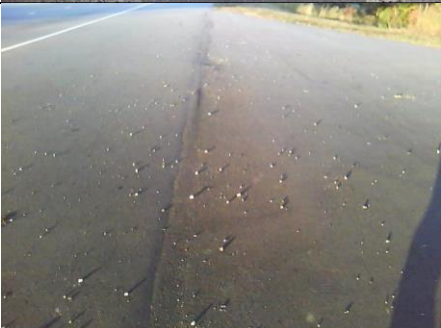
A47
6	Asphalt	LS_586	Travelway Sweeping

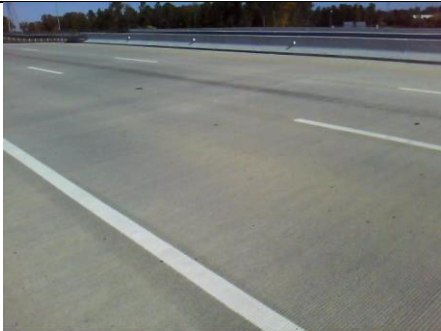
#	Material Type	Object ID	Failure Type	Photo	GIS Reference Page
1	Asphalt	LS_209	Reflective Markers	Not Available for Nighttime Failure.	A56
2	Asphalt	LS_256	Reflective Markers	Not Available for Nighttime Failure.	A48
3	Asphalt	LS_259	Reflective Markers	Not Available for Nighttime Failure.	A49
4	Asphalt	LS_281	Reflective Markers and Missing Markers

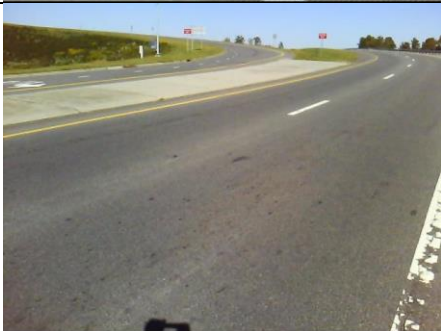
A54
5	Asphalt	LS_302	Missing Markers and Continuous Marker

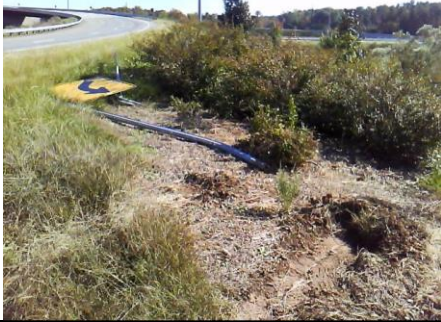
A52
2	Speed Limit Exit	SN_379	Missing Parts

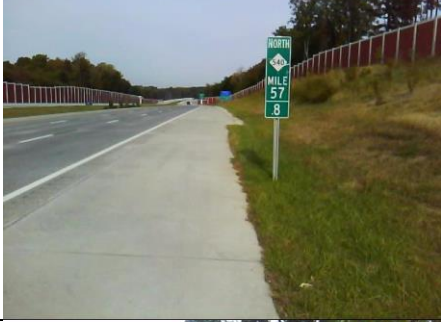
A6
3	Mile Post	SN_637	Lateral Clearance

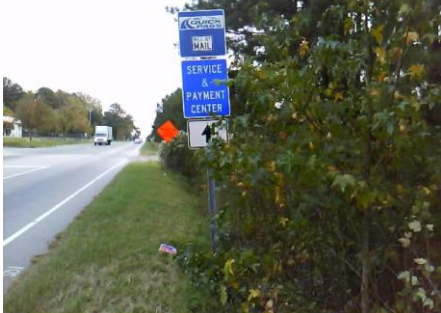
A35
4	Toll Other	SN_1002	Leaning

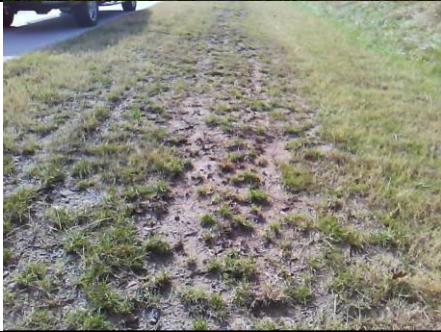
A22
2	Turf	TF_36	Bareground

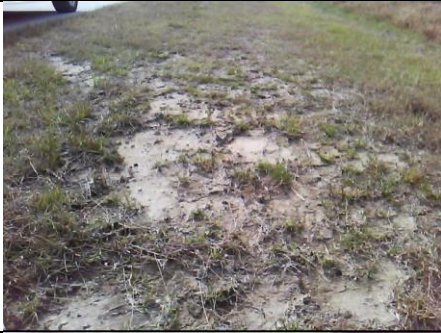
A15, A16
3	Turf	TF_41	Bareground

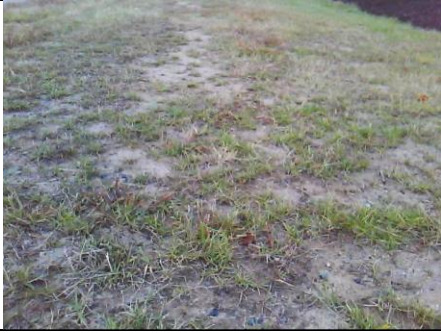
A21
4	Turf	TF_95	Bareground

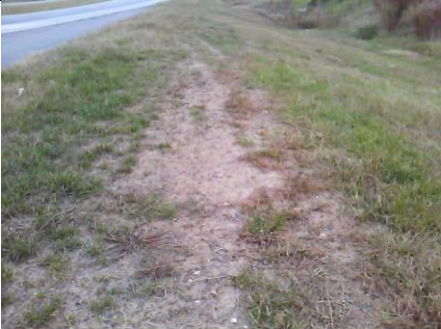
#	Material Type	Object ID	Failure Type	Photo	GIS Reference Page
5	Turf	TF_101	Bareground

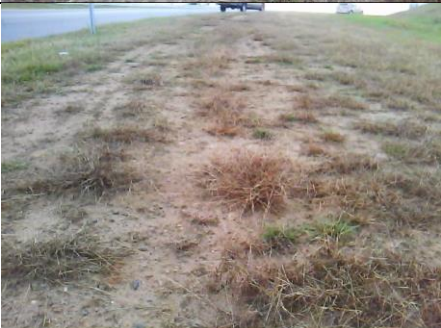
A44
6	Turf	TF_195	Bareground

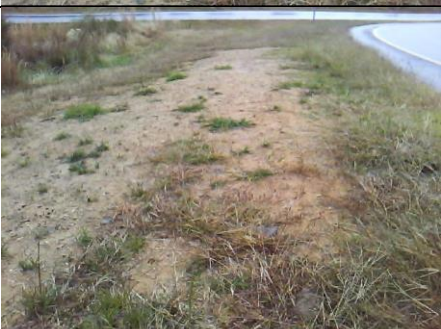
A47
7	Turf	TF_205	Bareground

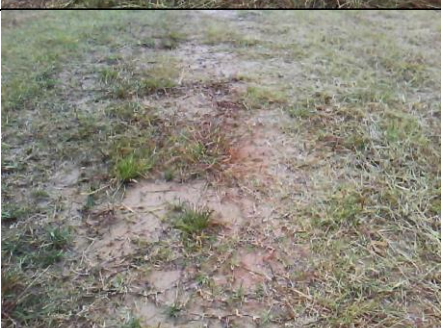
A30
8	Turf	TF_207	Bareground

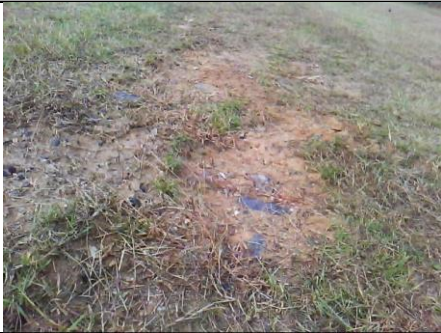
#	Material Type	Object ID	Failure Type	Photo	GIS Reference Page
9	Turf	TF_209	Bareground

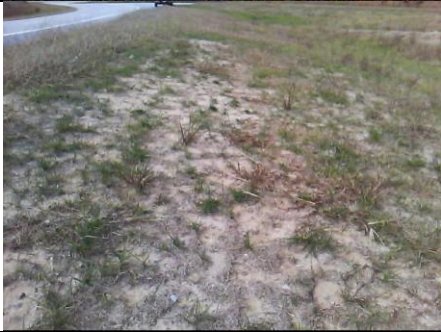
A28, A29, A30
10	Turf	TF_237	Bareground

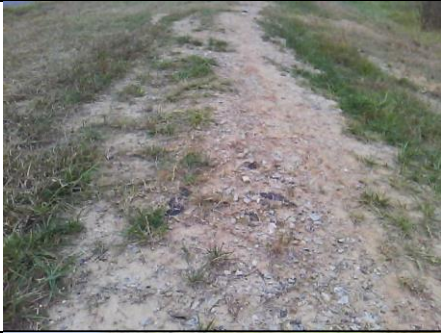
A39, A41
11	Turf	TF_241	Bareground

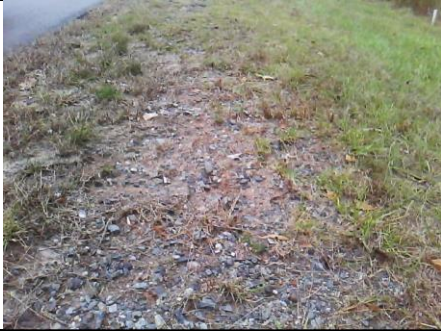
A40, A41
12	Turf	TF_255	Bareground

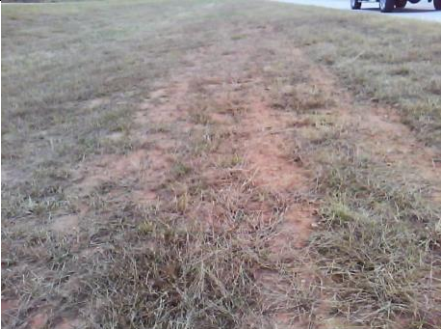
#	Material Type	Object ID	Failure Type	Photo	GIS Reference Page
13	Turf	TF_334	Bareground

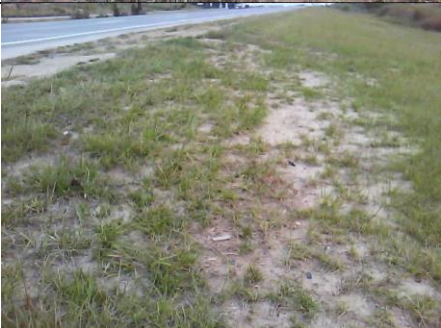
A43, A44
14	Turf	TF_390	Bareground

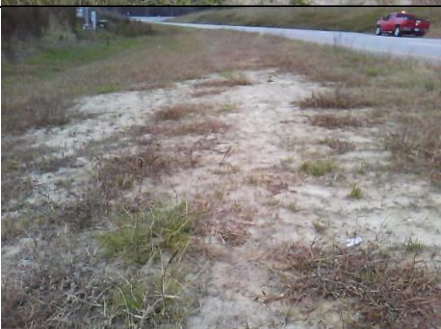
A39, A41
15	Turf	TF_394	Bareground

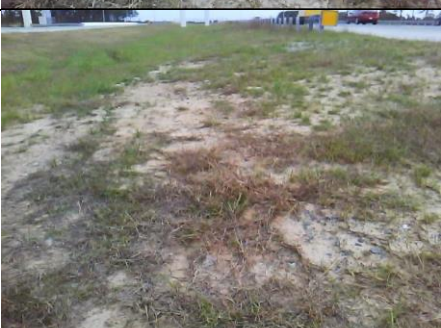
A39, A41
16	Turf	TF_396	Bareground

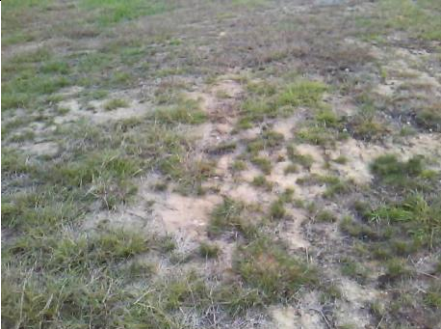
#	Material Type	Object ID	Failure Type	Photo	GIS Reference Page
17	Turf	TF_452	Bareground

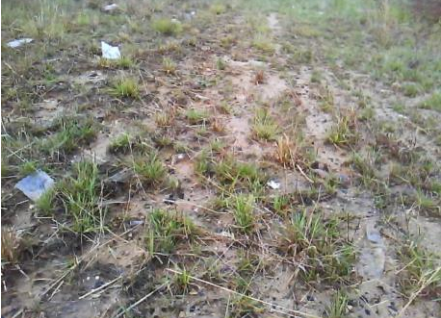
A34
18	Turf	TF_454	Bareground

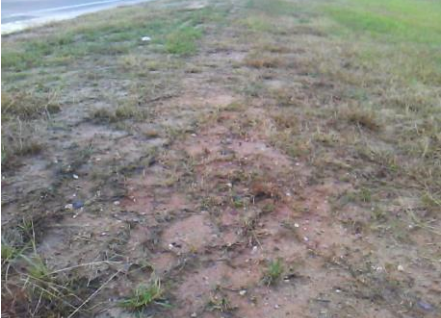
A47
19	Turf	TF_457	Bareground

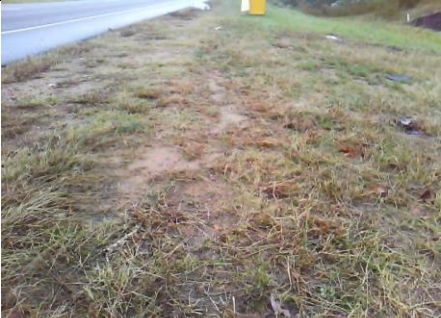
A47
20	Turf	TF_461	Bareground

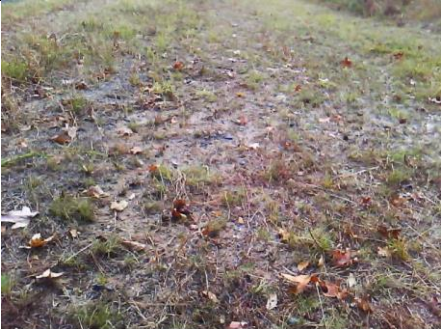
#	Material Type	Object ID	Failure Type	Photo	GIS Reference Page
21	Turf	TF_501	Bareground

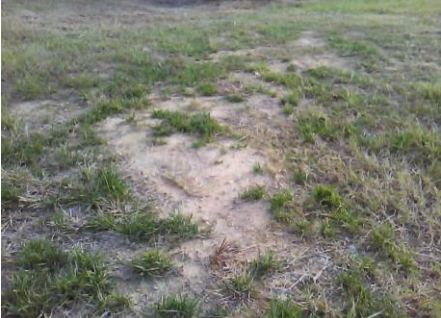
A31
22	Turf	TF_504	Bareground

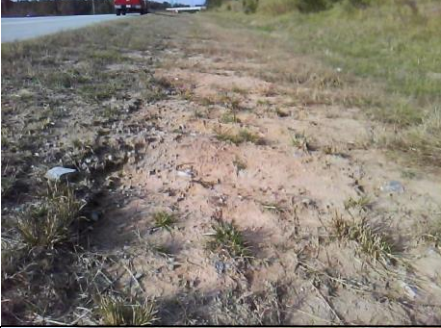
A29, A30, A31
23	Turf	TF_612	Bareground

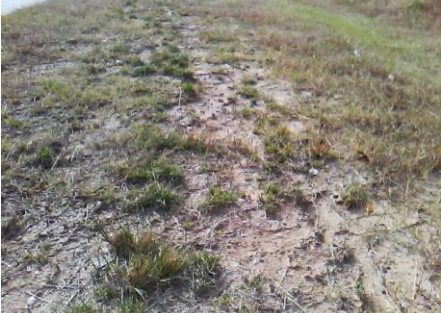
A18, A19
24	Turf	TF_614	Bareground

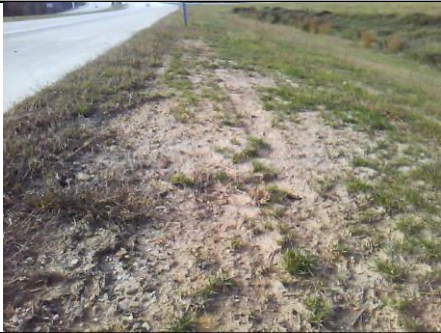
#	Material Type	Object ID	Failure Type	Photo	GIS Reference Page
25	Turf	TF_675	Bareground

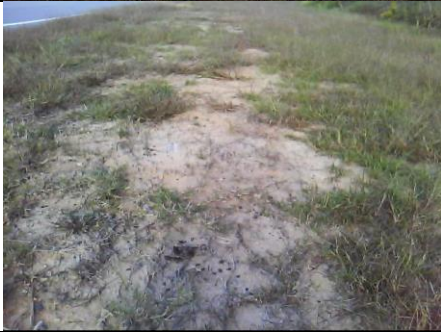
A12
26	Turf	TF_696	Bareground

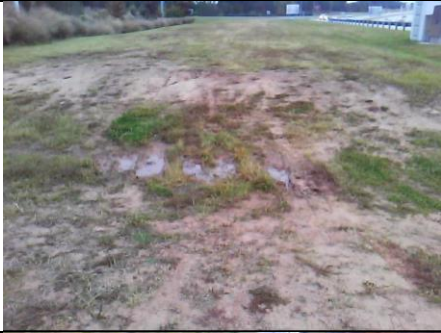
A12
27	Turf	TF_791	Bareground

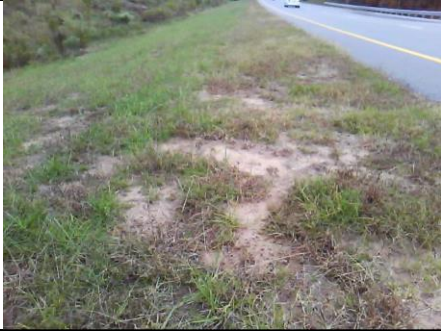
A5
28	Turf	TF_862	Bareground

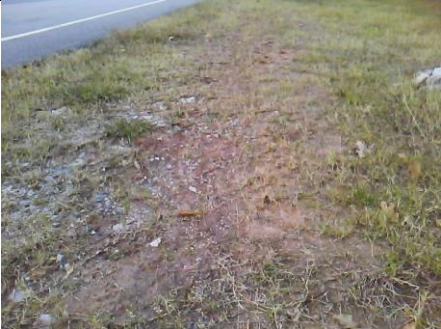
#	Material Type	Object ID	Failure Type	Photo	GIS Reference Page
29	Turf	TF_908	Bareground

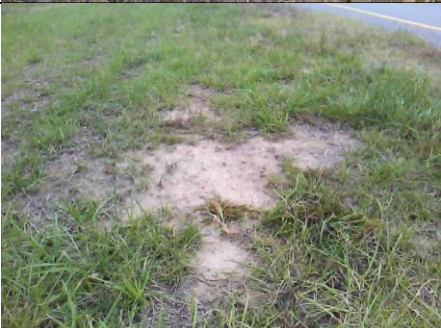
A53
30	Turf	TF_929	Bareground

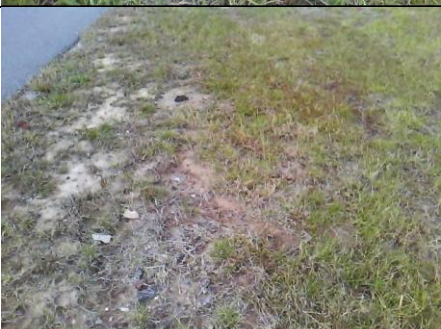
A52
31	Turf	TF_933	Bareground

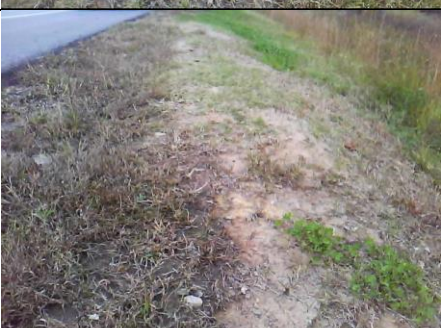
A52
32	Turf	TF_1003	Bareground
